Beecher Lake AIS Control Project

(ACEI-073-10.1)

Final Report

Marinette Co. LWCD
1926 Hall Avenue
Marinette, WI 54143

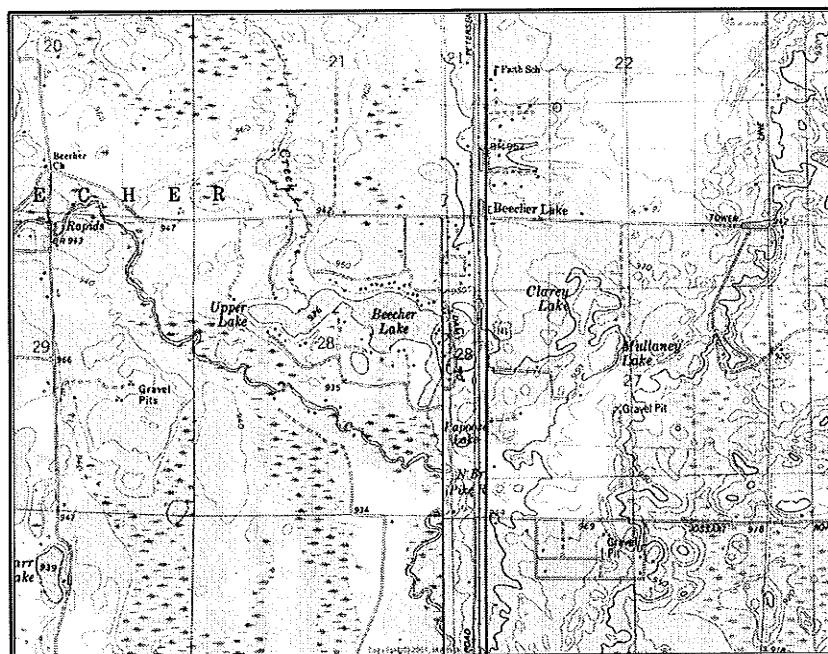
Figure 1. Beecher and Upper Lakes

Beecher Lake is located in the Township of Beecher (T36N, R20E, S28) in Marinette County, Wisconsin. The lake actually consists of two separate lakes, Beecher Lake and Upper Lake that are connected by a narrow channel. Locally the combined lakes are referred to as Beecher Lake. The lakes drain to the Pike River, an Outstanding Resource Water and State designated Wild River (figure 1).

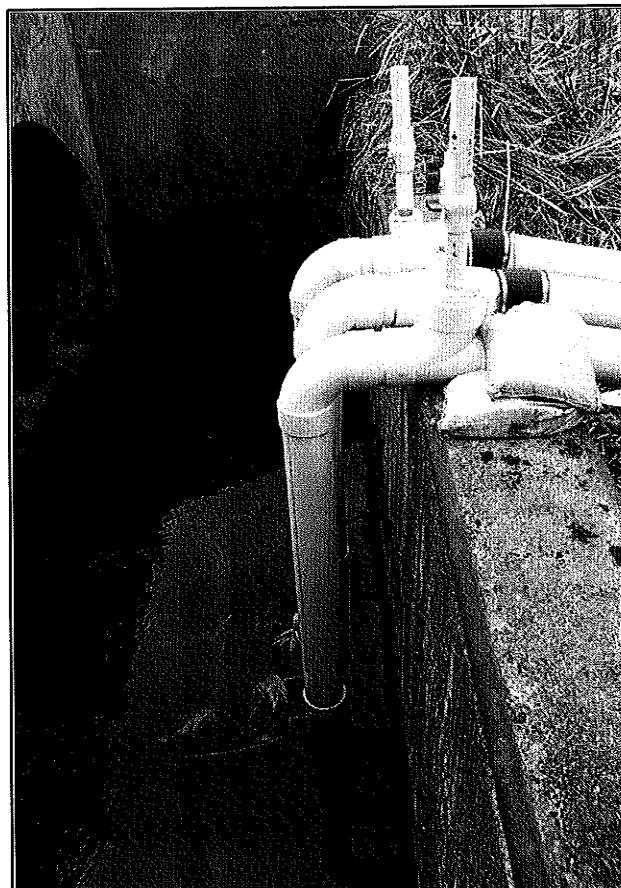
The winter drawdown was completed using siphons made from 6-inch pvc pipe and fittings available at most hardware or plumbing supply stores (figure 2). Each siphon consists of a 6-foot tall riser pipe, priming port, and intake pipe with anti-backflow valve and trash guard (figure 3). Strips of rigid foam insulation are fastened to the intake pipes to provide flotation. Intake pipes are joined using rubber couplers so they remain flexible as the water level drops and can be extended as needed. To prime the siphon, a tight fitting expansion plug is installed on the outlet end and water is pumped through the 2" priming pipe until the

Figure 2. Siphons are constructed using 6" PVC pipe and fittings.

siphon is completely full of water. When full, the ball valve on the priming pipe is closed and the plug is removed from the outlet.

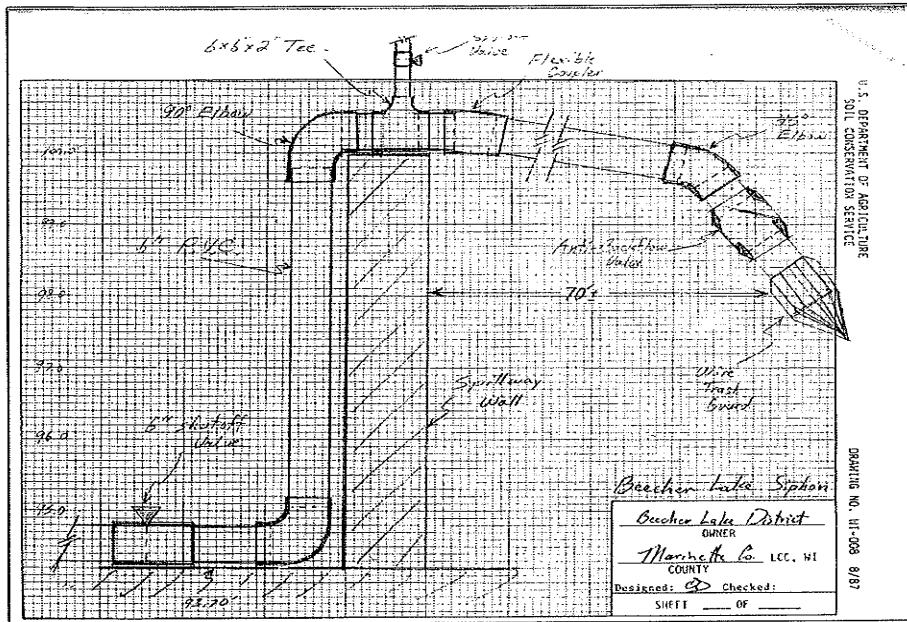
Figure 3. Beecher Lake siphon design.

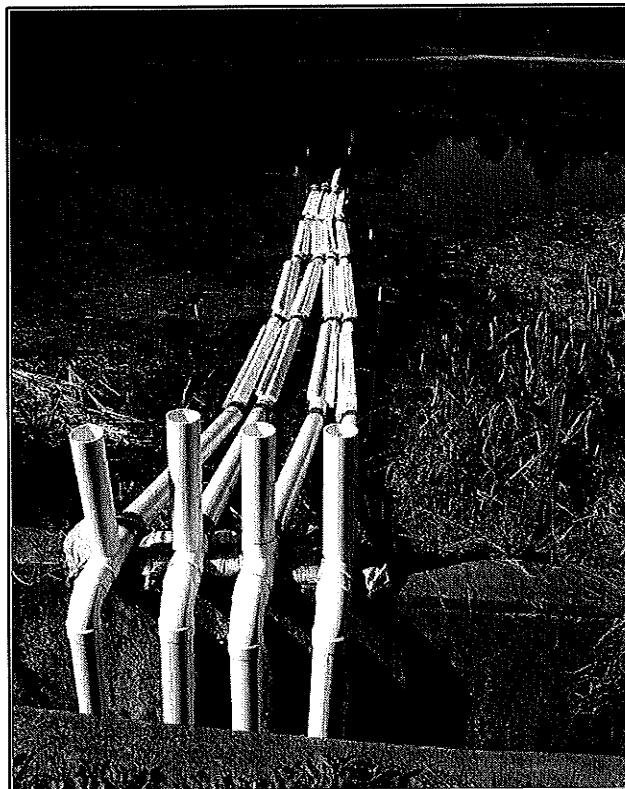
A second drawdown attempt was made in 2011 with the installation of four 80-foot long siphons on August 27 (figure 4). The water level fell rapidly and three siphons were extended to 120 feet on September 9. The lake elevation in front of the dam was 4.4 feet below full pool on September 18. By early October the water level was 5.0 feet below full pool, where it was maintained by two siphons (figure 5). Both siphons were removed on December 28 and the lake was allowed to begin refilling. Water levels in the lake rose slowly throughout the winter, returning to normal before ice-out in the spring of 2012.

Figure 4. Siphons installed at the Beecher Lake Dam.

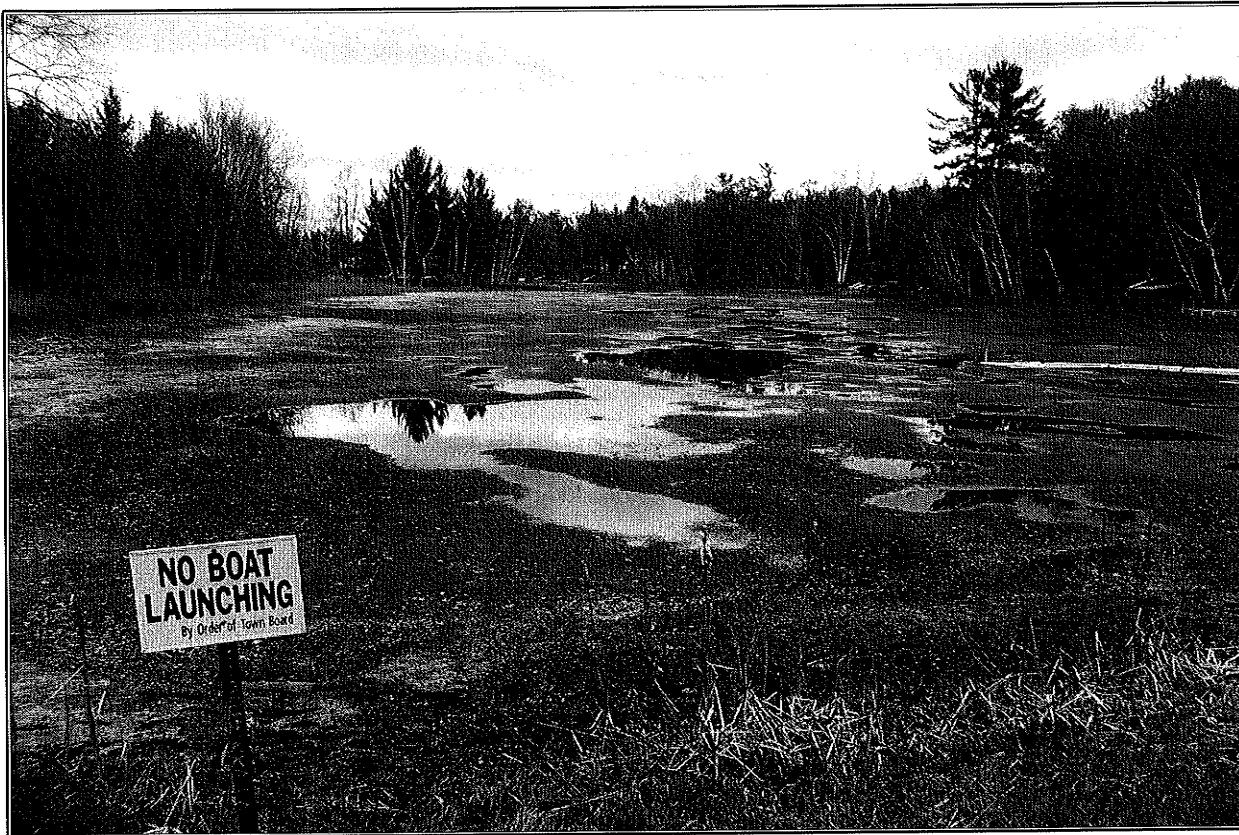
Figure 5. Five foot water level drawdown at the Beecher Lake Dam.

While the drawdown was successful in moving water over the dam it failed to achieve the expected water level reduction in Beecher and Upper Lakes. The Beecher Lake dam is located on Beecher Creek approximately 1,300 feet downstream from the lakes natural outlet. While the siphons did lower the water level near the dam, a build-up of sediment in the creek bed between the dam and the lake prevented the main body of the lake from draining sufficiently. A survey of the dewatered lake bed in December showed that the water level near the dam was 5 feet below full pool while 1,300 feet away, the water level in the main body of Beecher and Upper Lakes was only 2.5 feet below full pool.

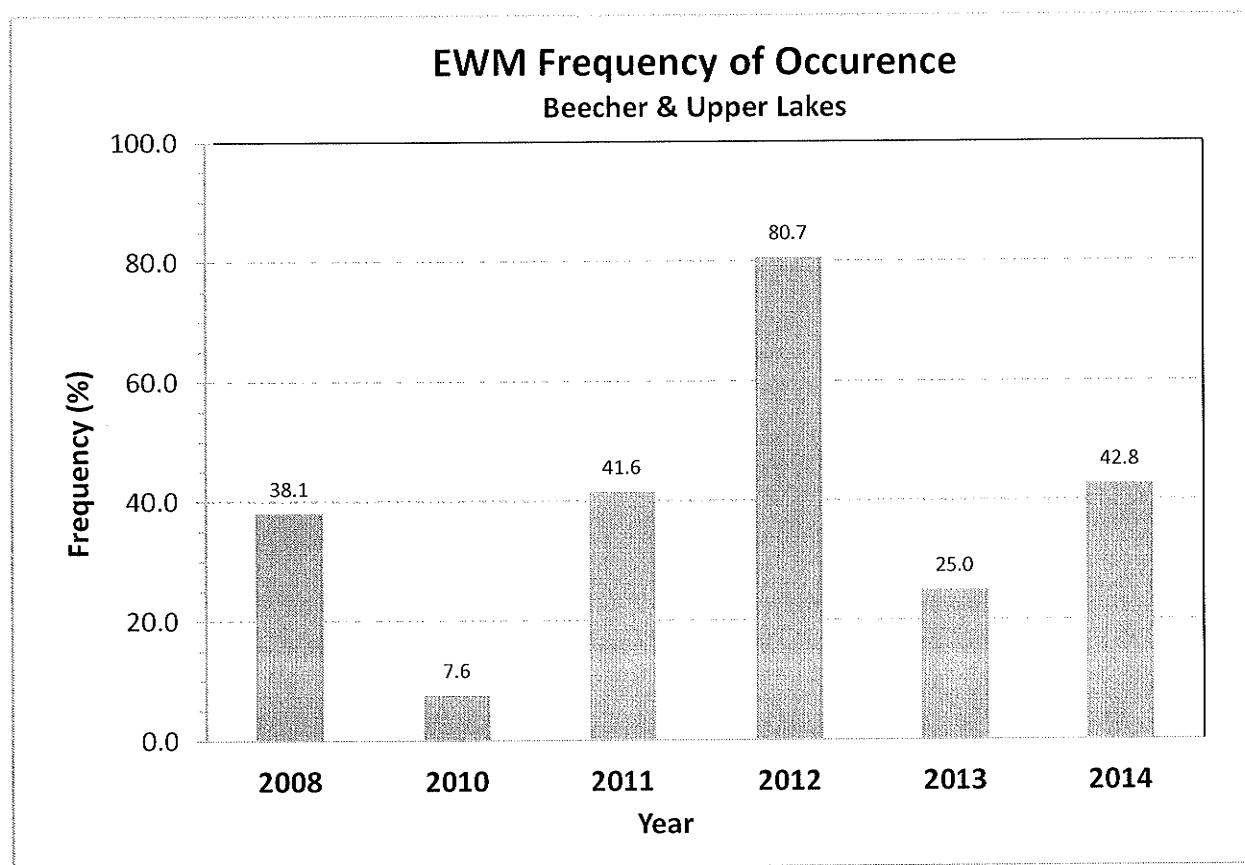
Unfortunately, the winter of 2011/12 was also exceptionally warm and less than three inches of frost penetration was achieved before snow effectively insulated the sediment. As a result, acceptable EWM control was not achieved in most areas of the lake. In fact, it appears that a non-lethal drawdown may have actually stimulated increased EWM growth. A detailed aquatic plant survey conducted after the drawdown showed a 94% increase in

Figure 6. EWM Frequency during the project period.

the frequency of EWM (figure 6). The one exception was the south arm of the lake near the dam where the drawdown was complete and the sediment was exposed for a much longer period of time. In this area EWM control was nearly complete and recolonization has been slow. As a result of this attempt, winter drawdown was abandoned as a management tool until the factors limiting its use can be resolved.

Shortly after its discovery in June, 2007 approximately 6.5 acres of moderate to dense EWM was mapped along the north and east shores of the Beecher Lake basin. By the fall of 2007 EWM had expanded to cover nearly 9.5 acres. Over the next several years, multiple herbicide treatments were conducted with mixed results (figure 6).

The whole-lake treatments conducted in 2013 and 2014 appeared promising at first but the effects were short lived. The 2013 treatment resulted in the greatest measured reduction in EWM frequency (69%). However, the apparent success seems to be, at least in part, a product of the timing of the aquatic plant survey. When the 2013 plant survey was conducted on July 18th EWM appeared to be well controlled and few plants were topped out. However, when the lake was re-visited in late August, EWM was topped out and had expanded to cover nearly 9.6 acres of the lake. In 2014 the treatment also appeared successful through the early summer. However, there was again a noticeable rebound in EWM by years end. When the aquatic plant survey was conducted on August 20 there was actually a measured increase in EWM frequency from the previous year (figure 6).

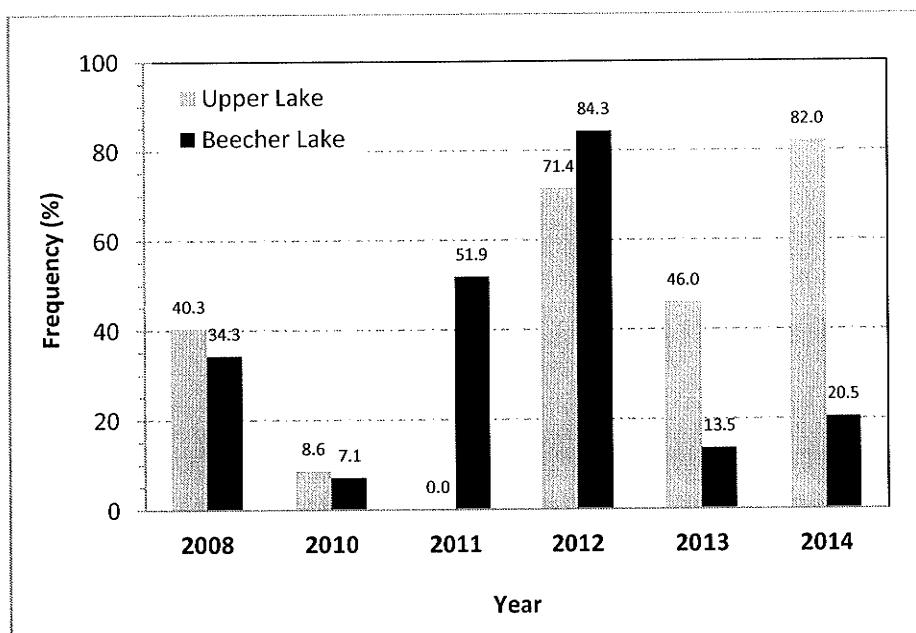
Figure 7. EWM frequency by lake basin.

Both whole-lake treatments resulted in better EWM control in the Beecher Lake basin and little or no control in the Upper Lake basin (figure 7). This may be due to increased flushing and dilution of the herbicide. The lake inlet is located adjacent to the boat landing on the north shore of Upper Lake. Flow from the creek likely follows the north shore of Upper Lake through the narrow channel between the two lake basins. EWM in this area of Upper Lake has consistently been difficult to control through chemical means.

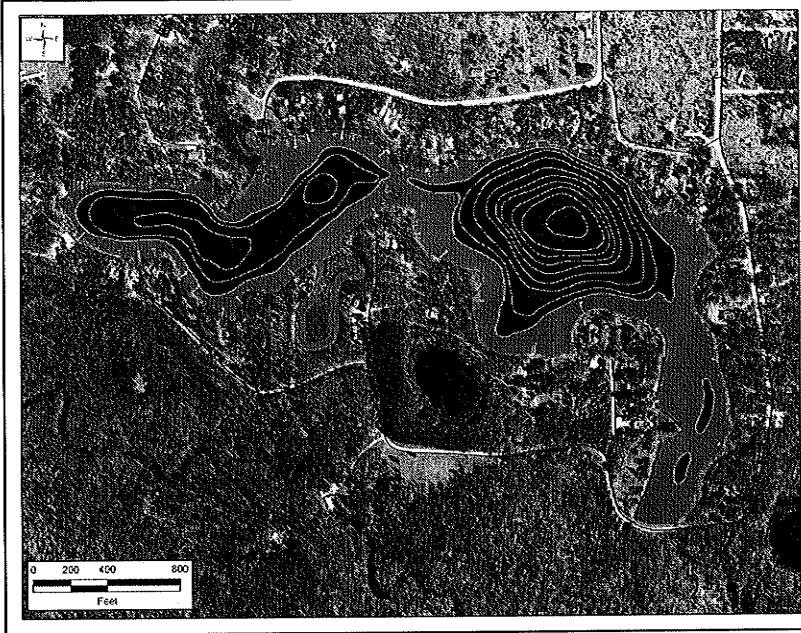
Figure 8. Area exposed by a 5-foot winter drawdown of Beecher Lake.

It will also be necessary to dredge a channel from the main body of the lake to the dam. This will greatly increase the maximum drawdown in the main lake basins, from the current 2.5 feet to 5.5 feet below full pool. When the maximum drawdown is achieved more than 76% of the littoral zone will be subject to freezing conditions and EWM control (figure 8).

necessary to modify the Beecher Lake dam to simplify the drawdown process. The installation of a drain pipe and valve through the Beecher Lake dam would allow for maintenance-free water level control as needed.

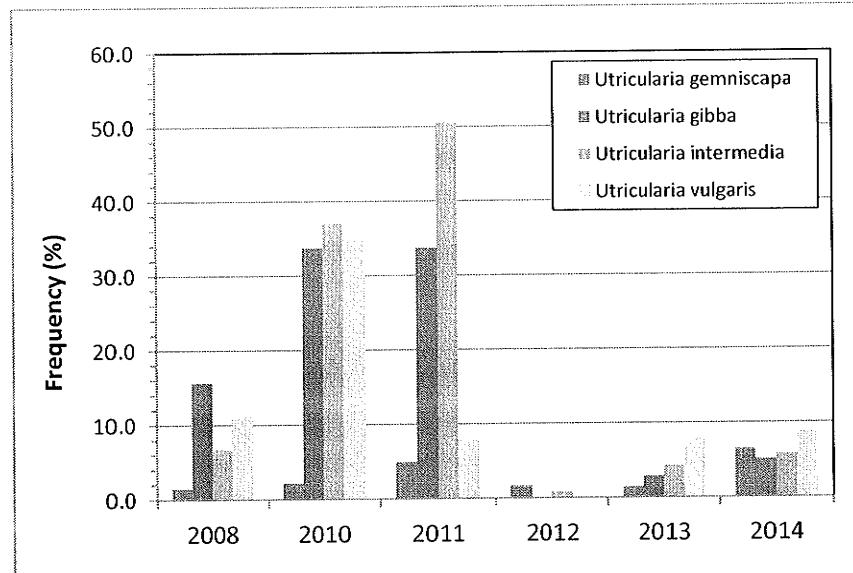
Figure 9. Changes in *Utricularia* frequency of occurrence in response to the winter drawdown.

(*Potamogeton gramineus*) increased. As a group, the bladderworts experienced significant declines following the winter drawdown (figure 9).

Although the winter drawdown did not result in sufficient sediment freezing for EWM control, there was a noticeable impact on several native plant species. Dominant species including coontail (*Ceratophyllum demersum*), and stonewort (*Nitella sp.*) declined in frequency while Bushy pondweed (*Najas flexilis*), muskgrass (*Char a sp.*) and variable pondweed

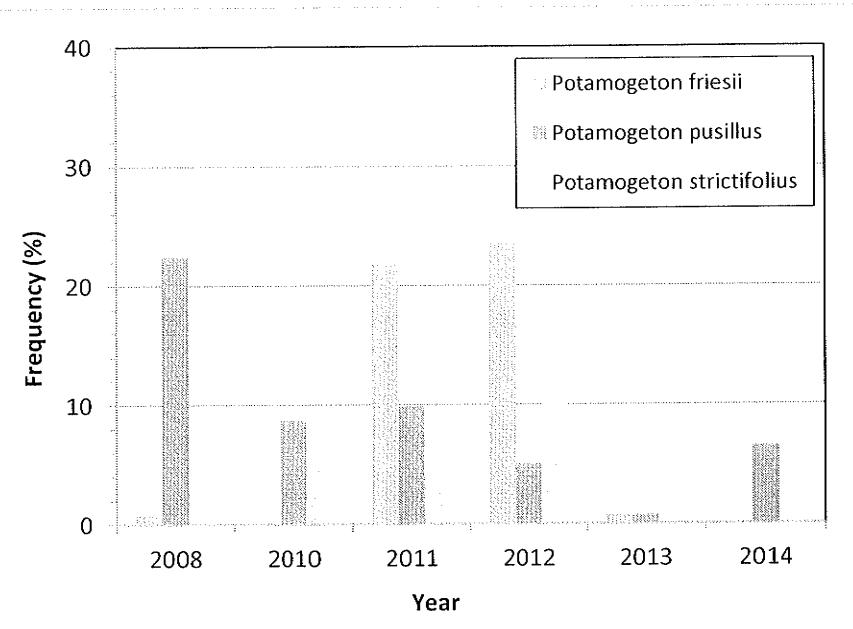
Figure 10. Selected small pondweed response to herbicide treatments in Beecher and Upper Lakes.

The relatively aggressive use of aquatic herbicides in Beecher and Upper Lakes during the last 7 years has impacted the native plant community. Watershield (*B. Schreberi*) experienced a significant decline as early as 2010. Many of the small pondweeds, most notably Fries’ pondweed (*Potamogeton fresii*), stiff pondweed (*P. strictifolius*), and small pondweed (*P. pusillus*) experienced significant declines (figure 10) in response to both the early -season 2,4-D spot treatments (2008-2010) and the whole-lake treatments (2013, 2014). No herbicides were used in 2011 or 2012 and all three species rebounded.
