# Beecher Lake EWM Control Project Phase II – Final Report

(AIS Control Grant # ACEI-172-15)

Chuck Druckrey  
Marinette County Land Information Department  
Land & Water Conservation Division  
June 2020

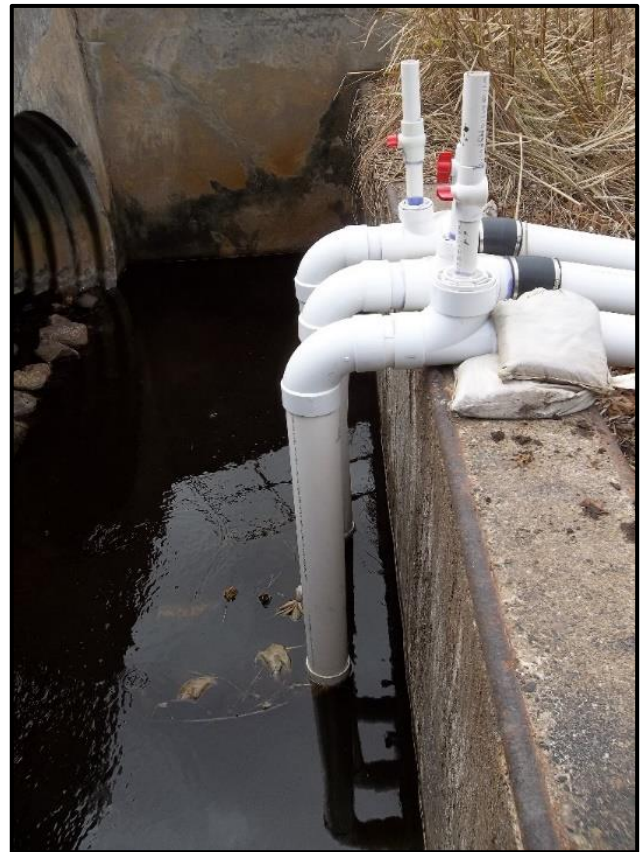
**Figure 2. 6-inch siphons created using off-the-shelf plumbing supplies.**

The Beecher Lake dam consists of a fixed weir spillway with a width of 24.5 feet. There are no gates or valves for water level control. Water level manipulation was completed using siphons made from 6-inch pvc pipe and fittings available at most hardware or plumbing supply stores (figure 2). A single siphon tube was installed in Beecher Lake in the summer of 2010 to demonstrate proof-of-concept. The test was successful and the siphon operated for two weeks without interruption.

Although the siphons were effective during warm weather, they were difficult to maintain during the winter as the pipes became encased in ice and frozen mud. While continuous flow prevented ice formation inside the pipes, any interruption in flow during sub-zero weather allowed the intake pipes to freeze solid in a matter of hours often rupturing the pipes and valves. These factors severely limit the utility of siphons for winter drawdown purposes.

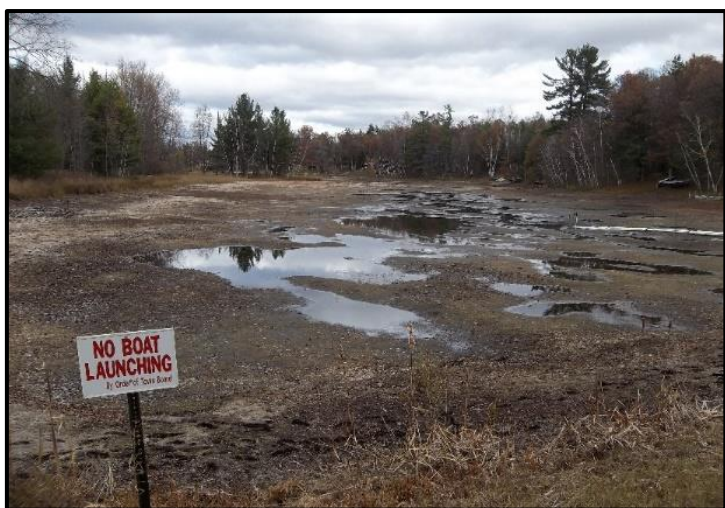
Figure 3. View of Beecher Lake near the dam following a "complete" drawdown.

A second drawdown was attempted in 2011 with the installation of four siphons on August 27. The water level fell rapidly and the lake level reached 5.0 feet below full pool by early October (figure 3). Unfortunately, the drawdown failed to achieve the expected water level reduction in the Beecher and Upper Lake basins. The Beecher Lake dam is located on Beecher Creek approximately 1,300 feet downstream from the lakes natural outlet. While the siphons did lower the water level near the dam, a build-up of sediment in the creek bed between the dam and the lake prevented the main body of the lake from draining sufficiently. A survey of the dewatered lakebed in December showed that the water level near the dam was 5 feet below full pool while 1,300 feet upstream, the water level in the main body of Beecher and Upper Lakes was only 2.5 feet below full pool. On December 28, 2011, the siphons were removed and the lake was allowed to begin refilling. Water levels rose slowly throughout the winter, returning to normal before ice-out in the spring of 2012.

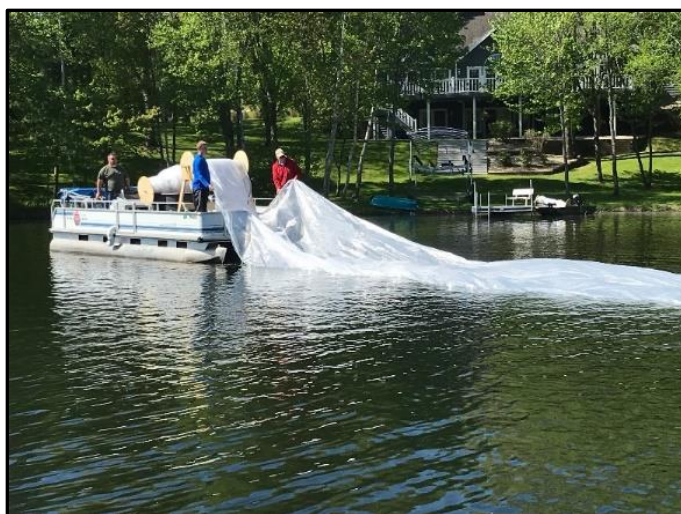
**Figure 13. Herbicide enclosure barrier being installed by LWCD staff.**
