Aquatic Plant Management Plan

Beecher Lake

Chuck Druckrey
Marinette County Land Information Department
Land & Water Conservation Division
January 2010

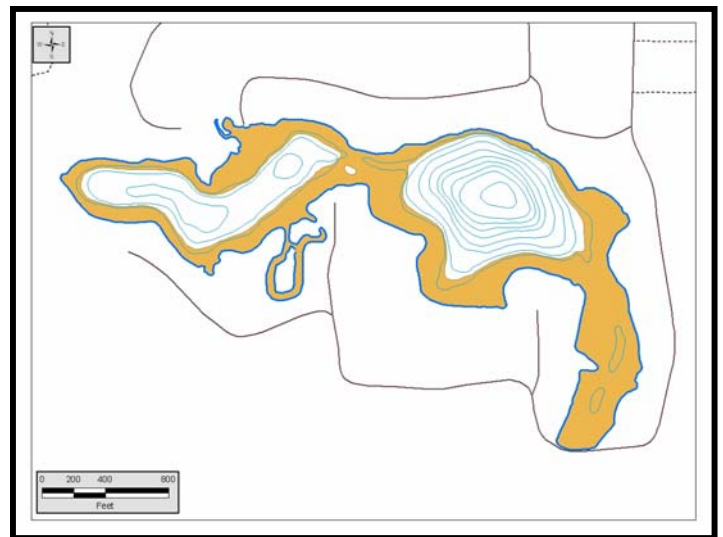
Figure 10. Area of sediment exposed by a 5-foot water level drawdown in Beecher Lake.

Pumping – While possible, pumping 83 million gallons of water from the lake would be a very expensive undertaking. For example, in

dewatering a local pond it cost \$6,000.00 to pump about 2 million gallons of water. At this rate, pumping 83 million gallons from Beecher Lake would cost almost \$250,000.00!

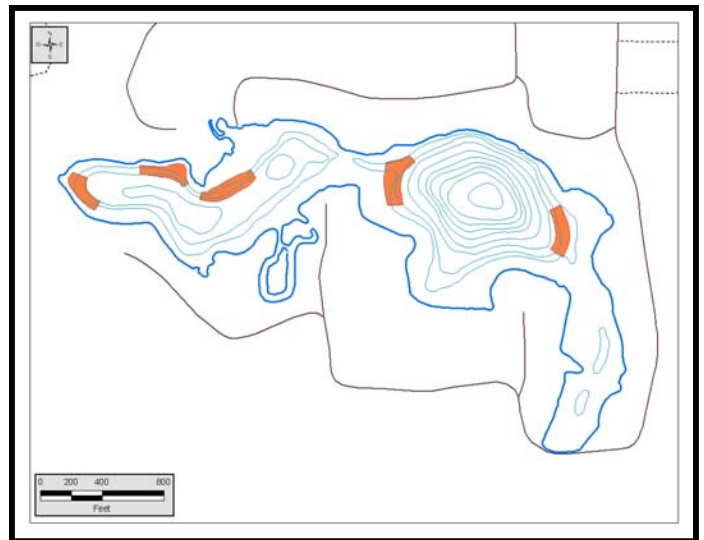
Figure 11. Proposed 2010 EWM herbicide treatment area.

The drawdown should be scheduled for the winter of 2010/11 if EWM growth is moderate to

dense in a significant portion of the lake as determined by a late summer plant survey. If EWM growth is sparse or limited in its spread the drawdown should be postponed until EWM growth rebounds somewhat. The goal is to have well-established EWM growth at least in some areas so the effects of the drawdown can be judged.
